COATING INTEGRITY SURVEY
USING DC VOLTAGE GRADIENT TECHNIQUE
AT KOREA GAS CORPORATION

R&D center / Korea Gas Corporation 277-1, 11-Dong Ansan, Kyonggi-Do 425-150 Korea

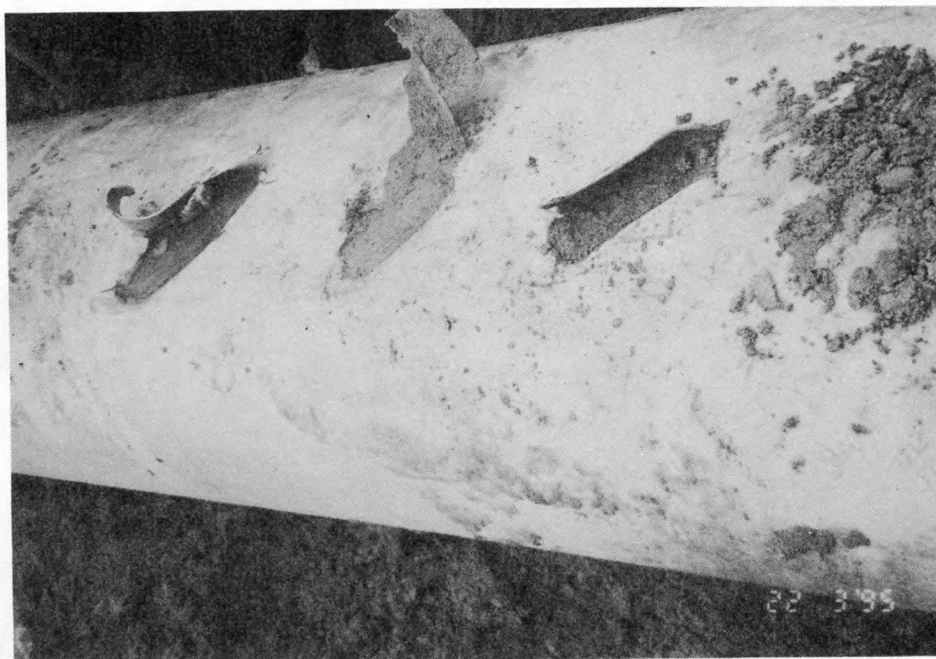
(a) spot-defect

Figure 1. Two types of coating defects

For the natural gas pipeline of 120 km, surveyors have found 106 points of assumed defects. In order to confirm the presence of defect and to repair, these assumed defects were dug out. Among 106 assumed defect points, 99 points were turned out to be real defects. Various types of defects were found : 77 defects were spot-like (Figure 1-(a)) and 22 defects were crack-like (Figure 1-(b)). These defects were repaired utilizing heat-shrinkable tape.
